National Transportation Safety Board

Highway Accident Brief

Accident Number: HWY14FH013

Accident Type: Motorcoach run-off-road and overturn

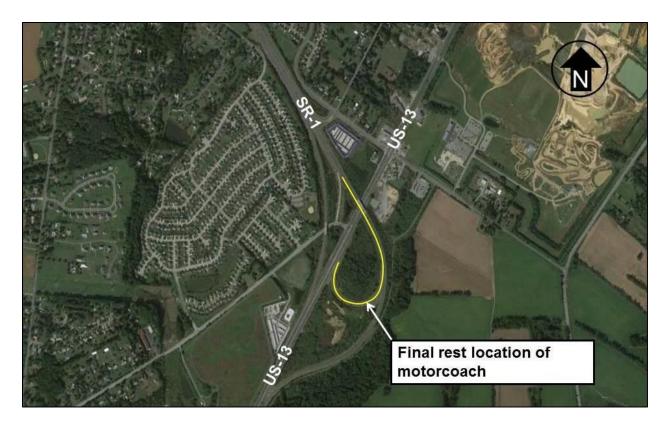
At the point where the SR-1 access ramp curves sharply to the right, the driver failed to negotiate the curve, and the motorcoach departed the left edge of the roadway. The motorcoach entered an earthen area, rotated clockwise, and overturned onto its left (driver) side and partially onto its roof, coming to rest about 25 feet off the roadway (figure 2).

Figure 1. Curved access ramp (yellow line) from southbound SR-1 to US-13 north, showing final rest location of motorcoach. (Sources: Esri, DigitalGlobe, GeoEye, Earthstar Geographics, Centre National d'Etudes Spatiales/Airbus DS, US Department of Agriculture, US Geological Survey, Aerials Express, Getmapping, Aerogrid, Instituto Geografico Nacional, Instituto Geografico Portugues, Swisstopo, and GISuser)
